Monitoring Completed Navigation Projects Program

Lock Wall Expedient Repair Demonstration Monitoring, John T. Myers Locks and Dam, Ohio River

October 2011

Final report

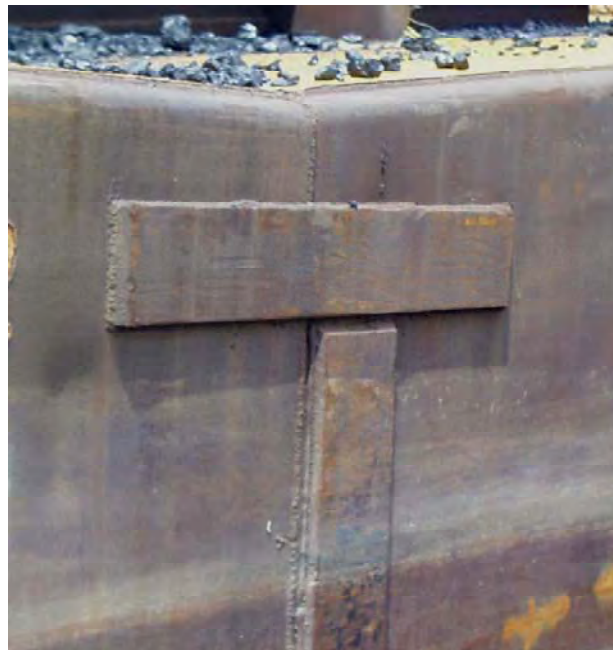
terminated near a monolith joint. Examples of this type of damage are shown in Figures 8 - 10. The relatively small concrete section between the end of the armor and the monolith joint is inadequate to resist the impact loads transmitted through the armor. Apparent bending of the armor beyond the last anchor also appears to contribute to localized crushing and subsequent loss of concrete section (Figure 9). Significant loss of concrete (Figure 10) makes these areas more susceptible to damage during chamber filling and emptying, particularly where barges have protruding steel plates such as shown in Figure 11.

Figure 11. Example of barge protrusions.

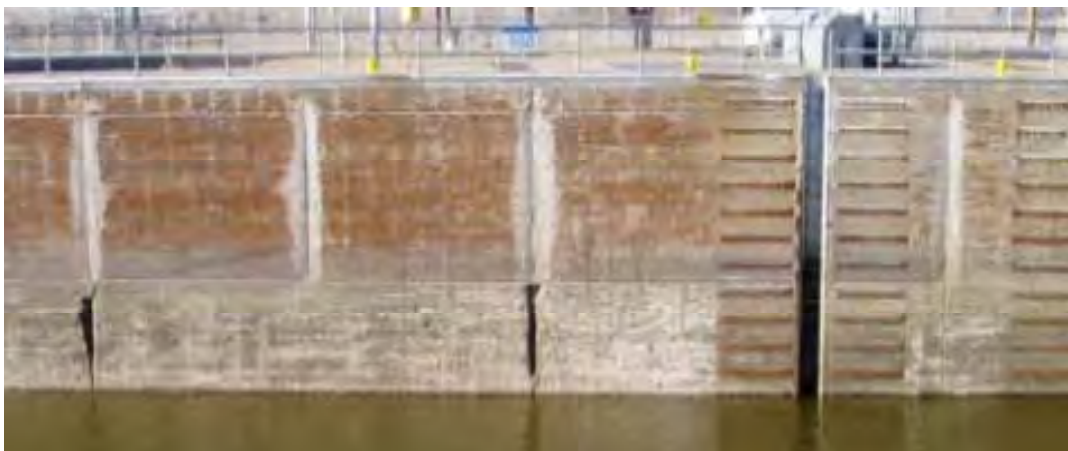
Figure 12. Recessed joint at Mississippi River Lock 22 after 7 years of service.

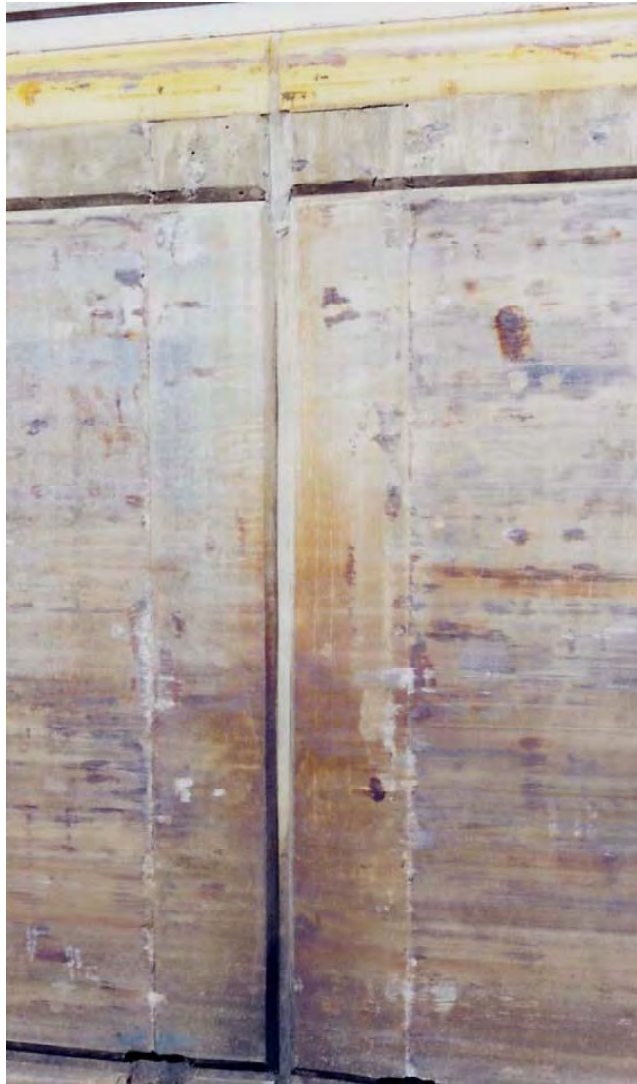
Figure 13. Precast panel joint at Allegheny Lock after four years of service.

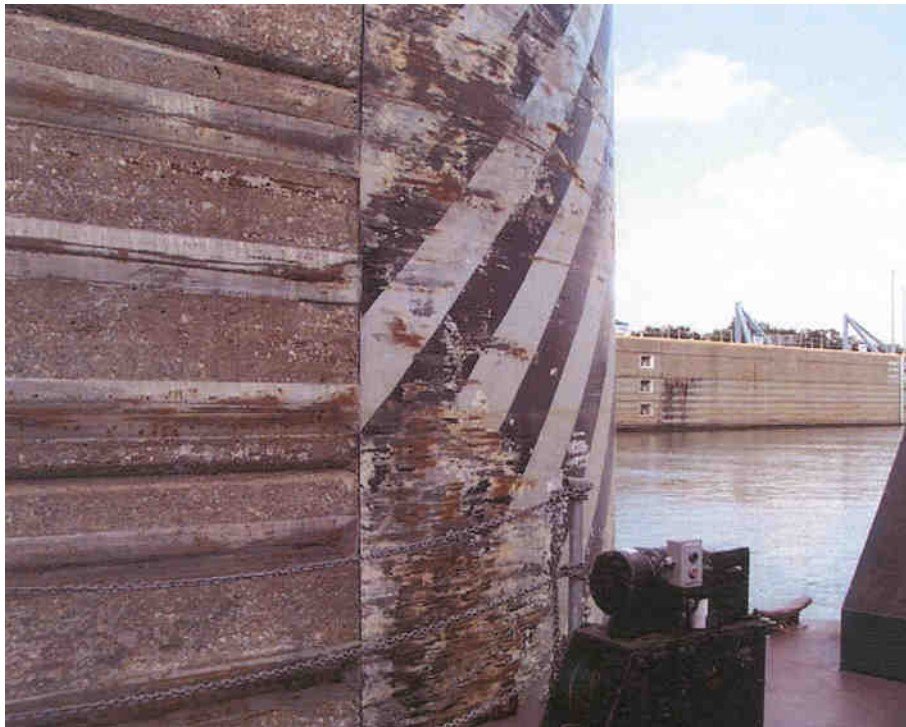
Figure 29. Steel encapsulated concrete, John T. Myers.

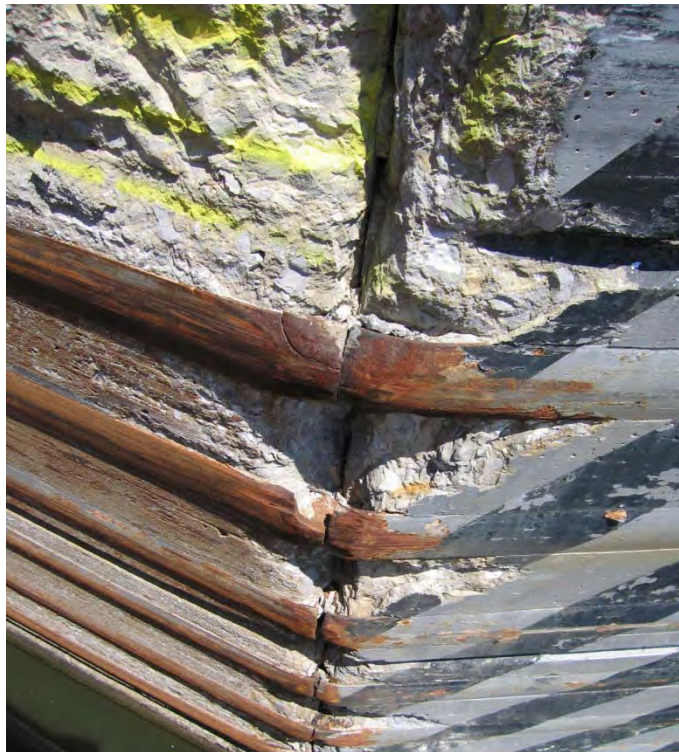
Figure 33. 600-ft chamber upper land-wall vertical joint selected for repair monitoring.

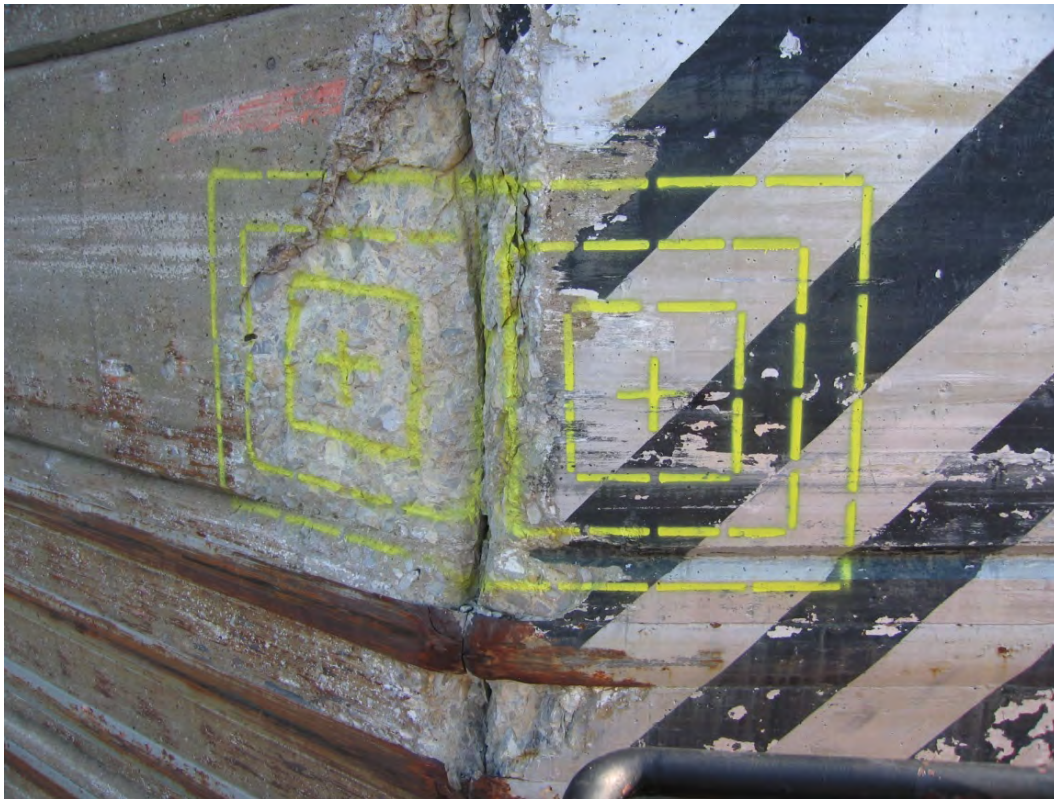
Figure 40. Template lines for identifying changes to damage area during monitoring.

Saw cuts by a diamond blade saw were made along the template lines 36 in. outside the joint on the upstream monolith L-36 and 48 in. outside the joint on the downstream monolith L-35 for a minimum of 2 in. deep or to sound concrete. A hand-held impact concrete breaker was used to dislodge concrete within the sawed area being repaired (Figure 43).

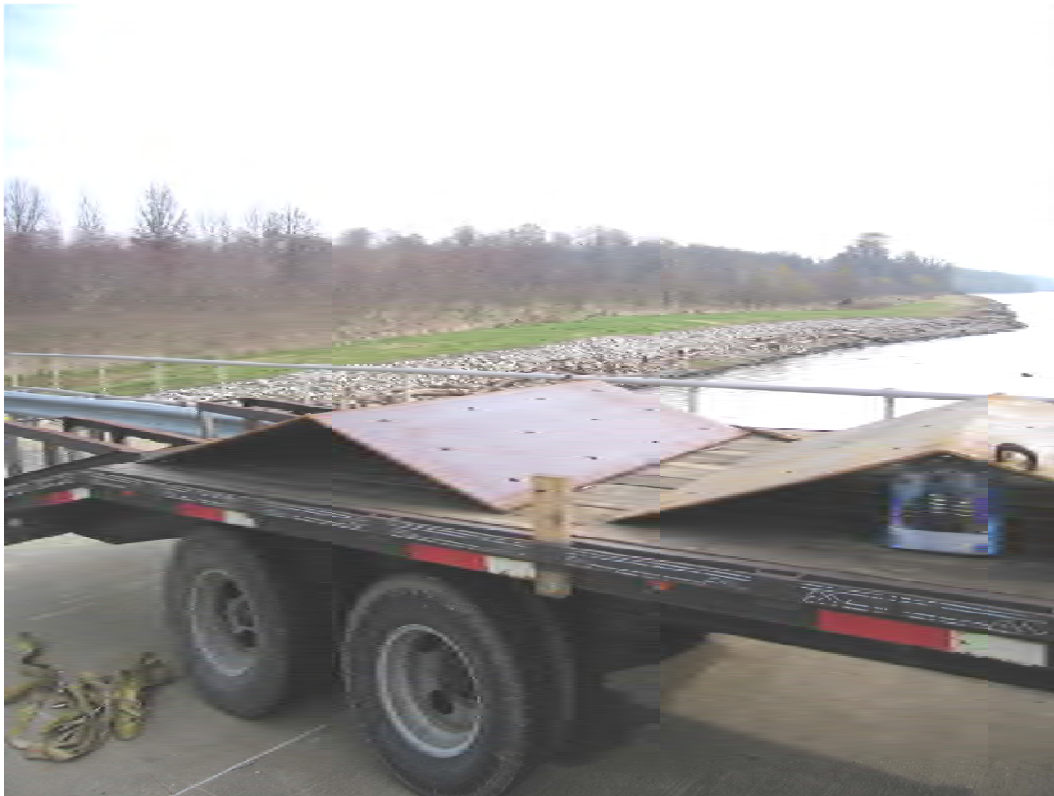
Figure 41. 7-ft-wide by 5-ft-tall steel plates arriving at the lock wall repair project.

The replacement steel plates would be 0.5 in. thick and 36 in. wide on the upstream monolith and 48 in. wide on the downstream monolith, for a total coverage of 7 ft wide. At the contractor's discretion, this steel plate could be one piece factory bent to fit the profile of the two monoliths, or it could be two pieces placed individually and welded at all seams. The total steel plate coverage would then be 140 sq ft. The contractor chose to install four pieces of steel plate, each 5-ft-high (20 ft total height) and 7-ft-wide, and each factory bent to fit the monoliths. Each individual steel plate covered 35 sq ft, and the total coverage for the four steel plates was the required 140 sq ft. Figure 41 shows the 7-ft-wide by 5-ft-tall factory bent steel plates arriving at the work site.

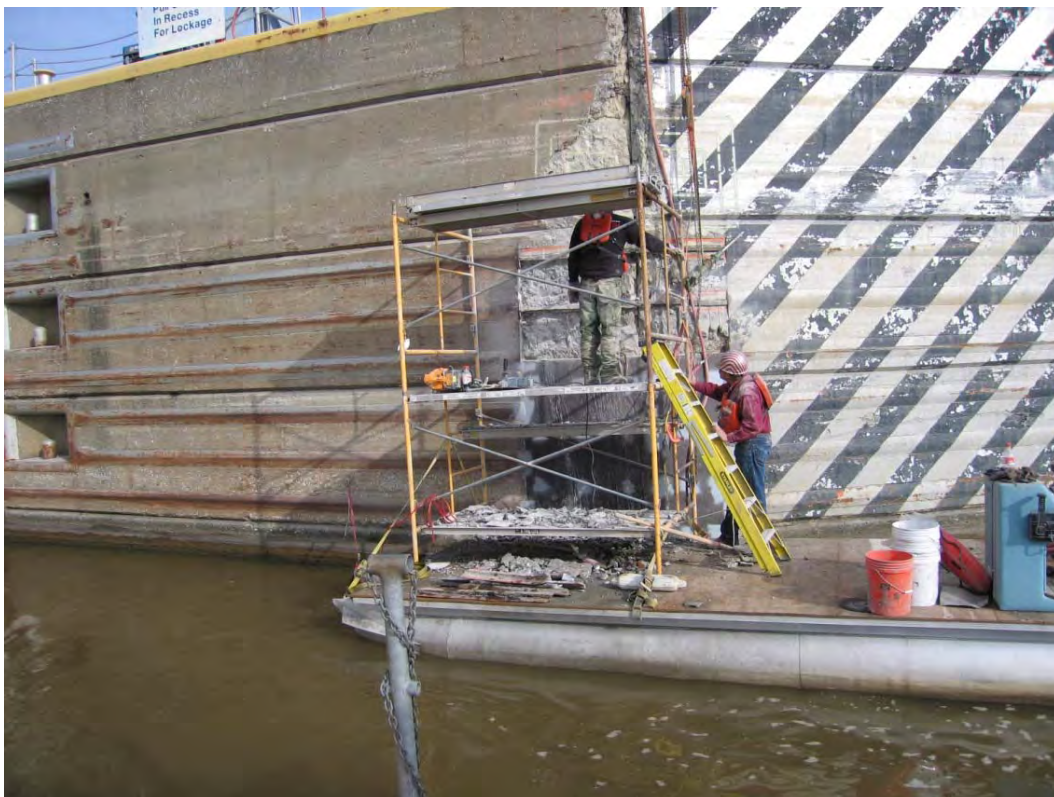
Figure 42. Pontoon float work barge for performing repairs to lock vertical joint.

A pontoon float multi-level work barge was assembled for performing the repairs to the lock vertical joint. The scaffolding on the 20-ft-long by 8-ft-wide self-propelled work barge was two tiers high. Figure 42 shows the contract crew sawing and power chiseling deteriorated concrete from the region to be repaired with high-early-strength, quick-setting concrete. (In this photo, the bottom section of 7-ft-wide by 5-ft-tall steel plate had already been installed, and the contract crew was preparing to install the second section of steel plate.)

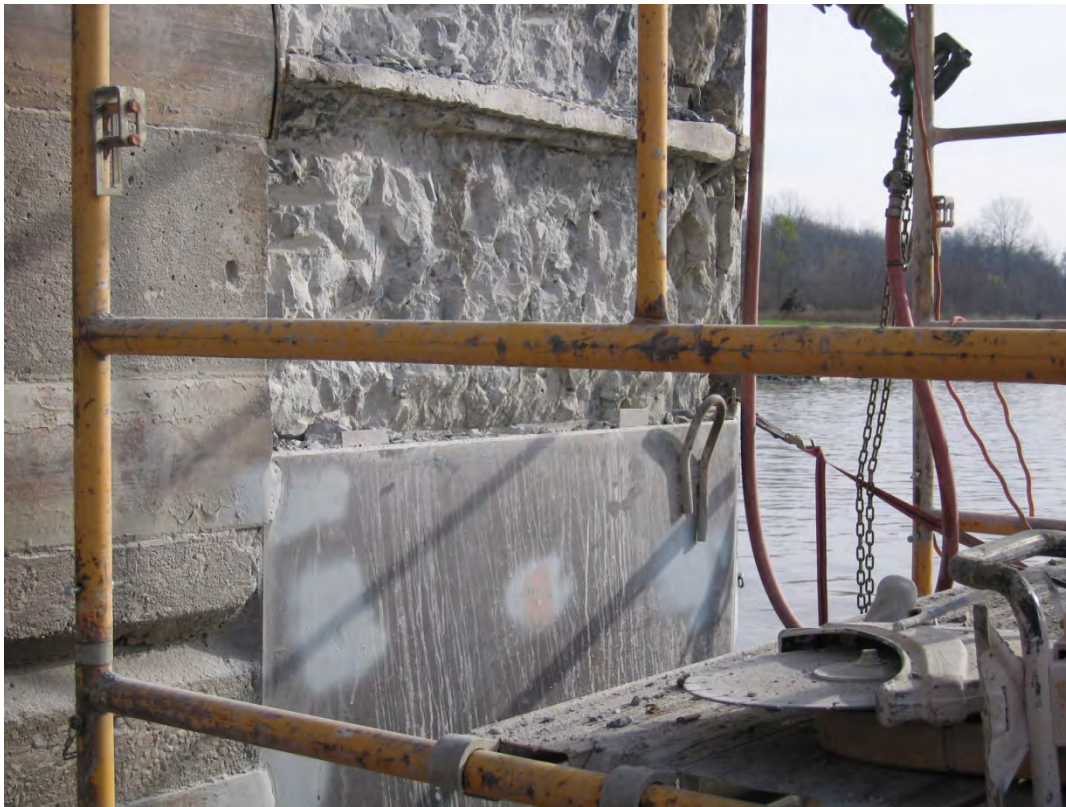
Figure 44. Cavity prior to installation of concrete anchor bolts and steel plate anchor rods. Bottom section of steel plate is shown with anchor rods welded to plate and smooth finished.

The existing wall armor rub strips were beveled to smoothly blend with the new armor steel plate. The concrete surface within the repair region was cleaned by flushing with river water under high pressure to remove any debris that was left after removal of deteriorated concrete. Figure 44 is a close-up photo of the cavity prior to installation of internal bolt-and-nut anchors. Here can be seen the lower 5-ft-high steel plate that was previously installed, with the locations of the steel plate anchor rods visible after the rods were welded to the steel plate and smooth finished down to the surface of the plate.

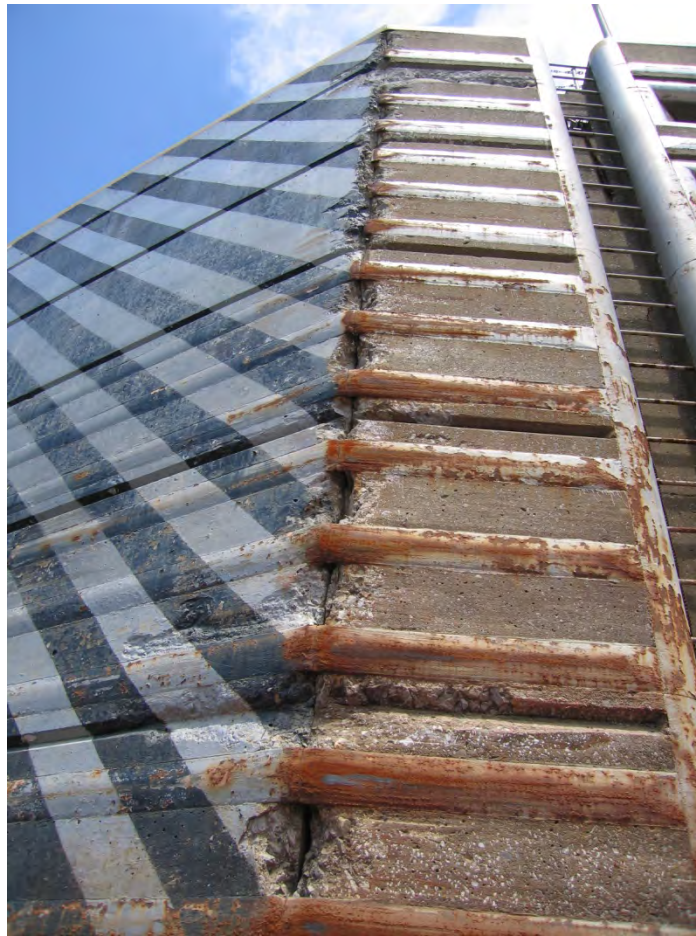
The lock wall design at the lower vertical joint is significantly different from the wall design at the upper lock (Figure 47). Here, the wall armor rub strips extend all the way to the top of the wall on monolith L-2 (the main lock chamber wall), but terminate about 13.5 ft below the lock wall on monolith L-1 (the guide wall entrance into the main lock chamber).

Figure 47. 600-ft chamber lower land-wall vertical joint selected for repair monitoring.

The contractor shall furnish, fabricate, and install supplemental wall armor and repair concrete damage/deterioration located on the 600-ft lock chamber's lower land-side approach wall at the joint between monoliths L-1 and L-2. The area of repair to the wall armor may span up to a height of 35 ft and a width of 2 ft 0.75 in. (1 ft on each side of expansion joint, and 0.5 in. to 0.75 in. expansion joint width). The area of repair to the concrete will be similar with exception to filling a 2-ft-wide by approximately 5-ft-long void from missing wall armor near the top of monolith L-2.

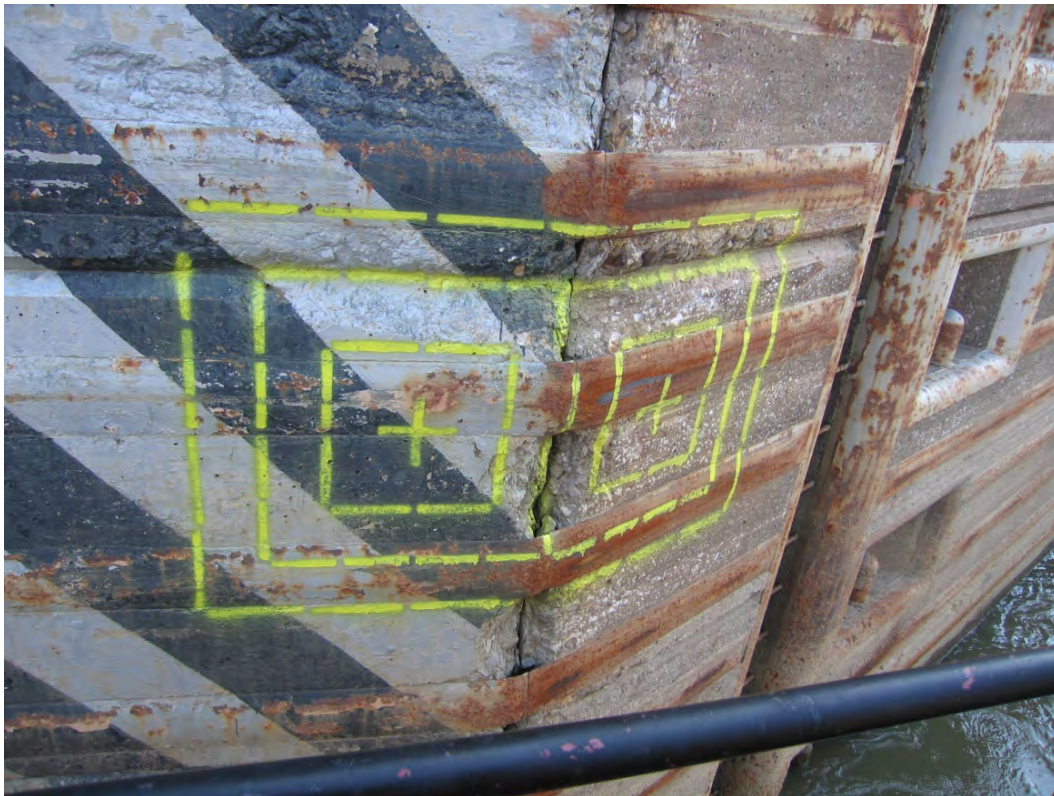
Figure 51. Template lines for identifying changes to damaged area during monitoring.

An example of the severity of the damage to the concrete at the lower land-wall approach vertical joint that required repair is shown in the close-up photograph of Figure 50. The contractor was directed to saw-cut and chisel to remove damaged concrete to a depth of at least 2 in. or to sound concrete. The cavity shown in Figure 50 is approximately 12 in. deep. The lateral extent of the concrete removal would be only 12 in. on each side of this vertical joint, as contrasted with 36 in. and 48 in. on either side of the upper land-wall approach vertical joint. To accommodate the repair wall armor steel plates, the contractor would be required to cut 12.5-in.-long by 2-in.-high notches in the existing wall armor rub strips. The repair steel plates would be fully welded to the existing wall armor rub strips, as well as attached to the concrete walls by anchor rods. Figure 51 shows template markings for removal of the damaged concrete prior to the installation of the repair steel plates.

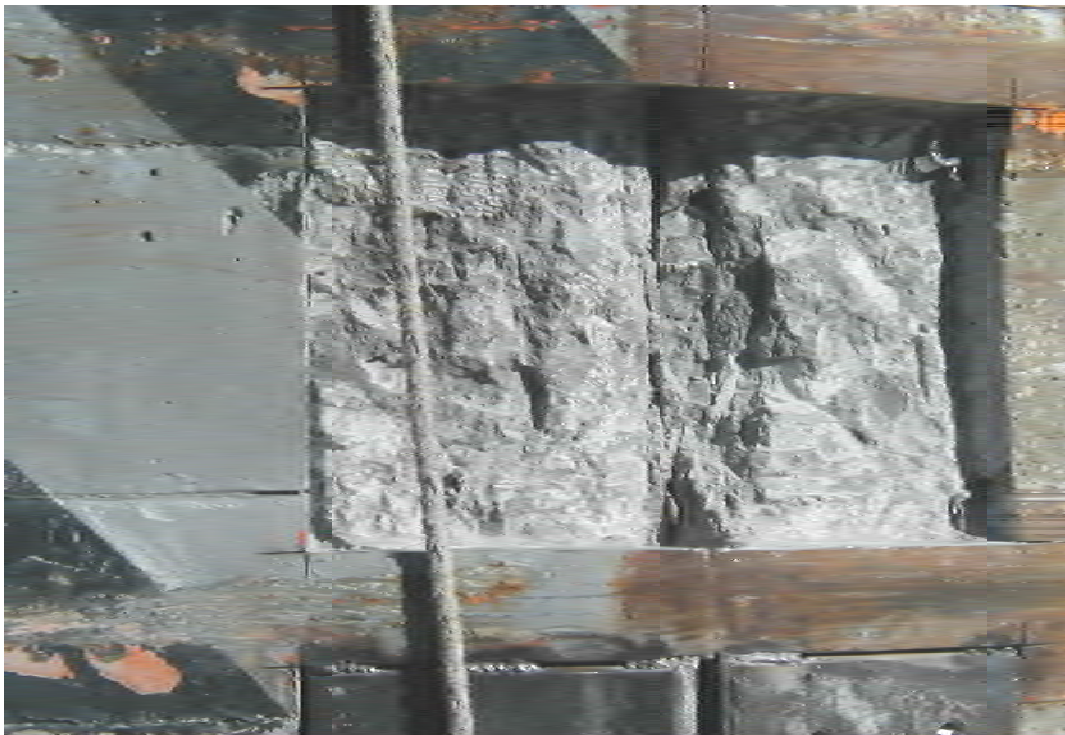
Figure 52. Cavity prior to installation of steel plate anchor rods.

A closeup view of a section between two armor wall rub strips is shown in Figure 52 after the damaged concrete was saw-cut and chiseled down to solid concrete. The top and bottom of the armor wall rub strips had been removed before this photograph to allow for installation and welding of the repair steel plates to the rub strips. Next, four anchor rods would be installed for each repair steel plate, as per manufacturer's recommendations in Figures 37a through 37e (specification sheets for an example acceptable material).

Four holes were previously drilled in each of the repair steel plates, each hole being located approximately 3 in. from each edge of the four corners of the plates. Anchor rod holes were drilled into the concrete cavity to match the hole locations in the steel plates, following manufacturer's recommendations for hole size, depth, and preparation. The anchor bolts were installed, and the epoxy was allowed to cure. Next, the contractor sealed the monolith joint with polyurethane closed-cell marine foam. Then, a grout mixture was spread to fill the cavity void and form a base for the backside of the repair steel plates. Specification sheets for an example acceptable mineral-aggregate grout mixture are shown in Figures 49a thru 49d.

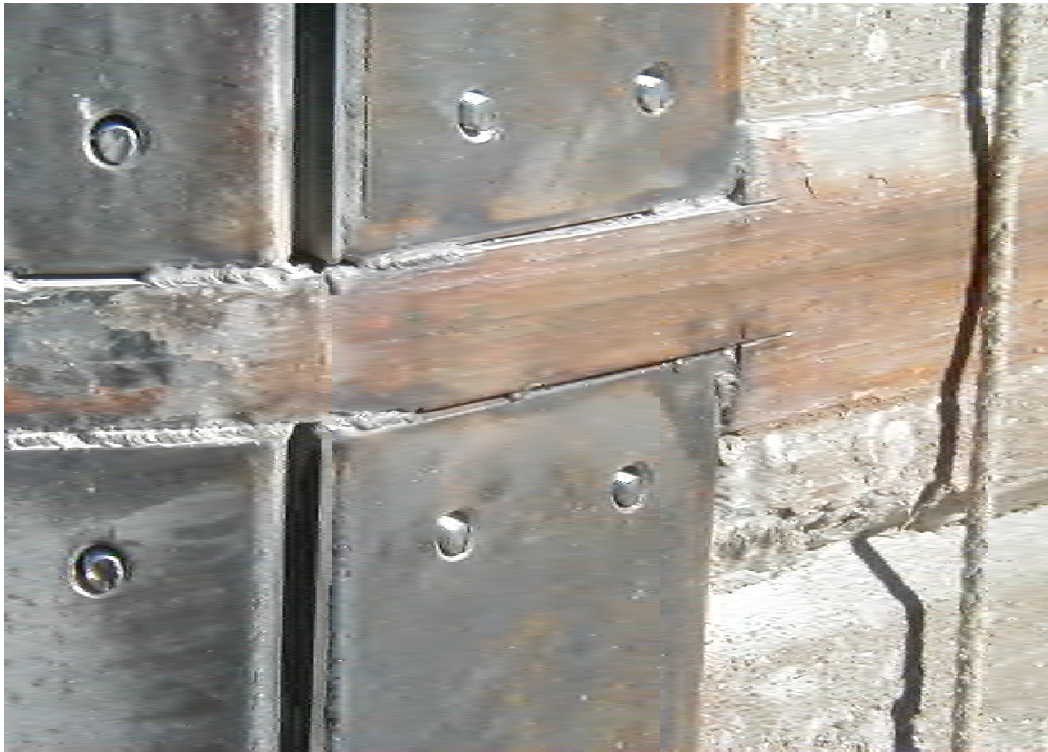
Figure 53. Repair steel plates being welded to the wall armor rub strips, prior to welding the anchor bolts to the steel plates.

The repair steel plates were placed onto the anchor bolts by utilizing threaded nuts on both sides to adjust the plates flush with the top surface of the existing wall armor rub strips. The steel plates would be full welded along the horizontal joints between the plates and the rub strips, and the outer anchor rod nuts would be removed. This would allow the anchor rods to be welded solid to the steel plates and ground flush with the face of the plates. Figure 53 shows four of the repair steel plates being attached to the wall armor rub strips, with the outer rod nuts removed but prior to completion of the welding. Figure 54 shows a section of the vertical joint repair with the lower repair steel plates fully welded to the wall armor rub strips and the anchor bolts welded and ground down to the plates. Figure 55 is a wider view of the repair activities, showing the vertical extent from the pool water line to the top of the lock wall.

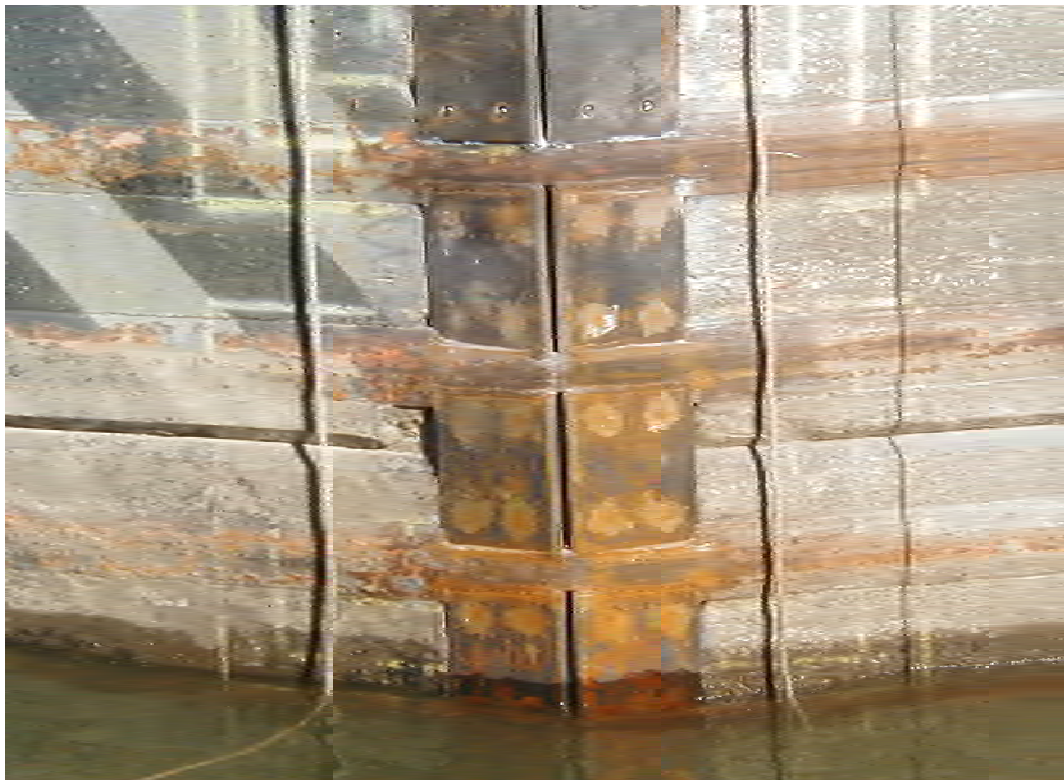
Figure 54. Repair steel plates fully welded to the wall armor rub strips, and the anchor bolts welded and ground down to the plates.

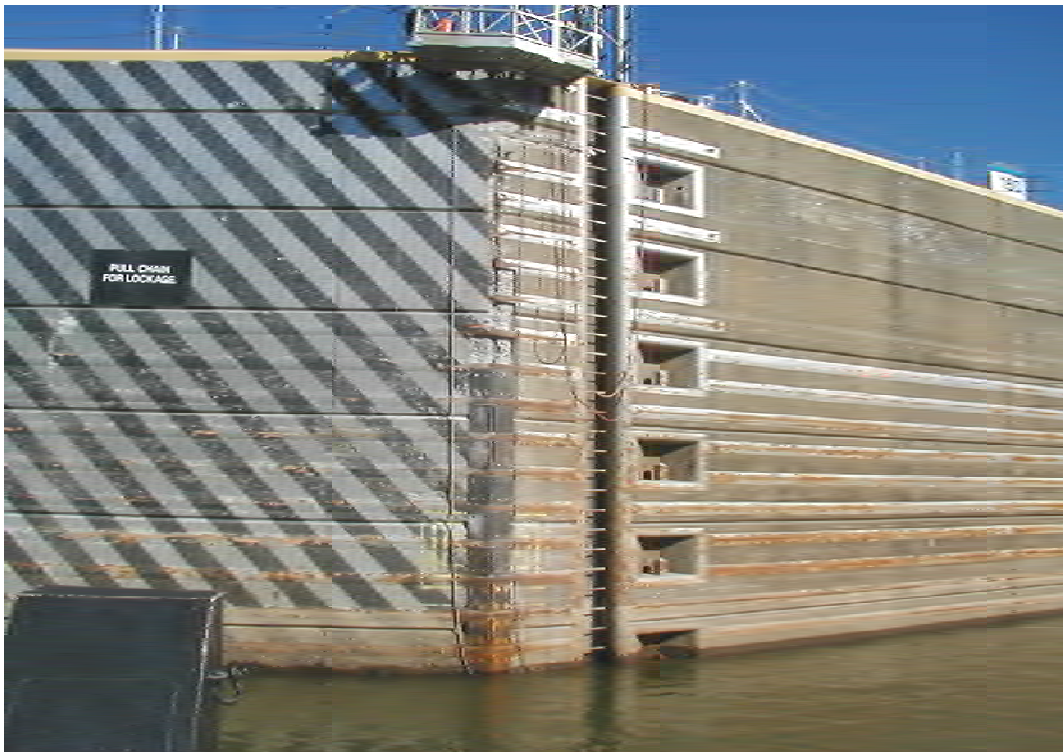
Figure 55. 600-ft chamber lower land-wall approach vertical joint during repair activities.

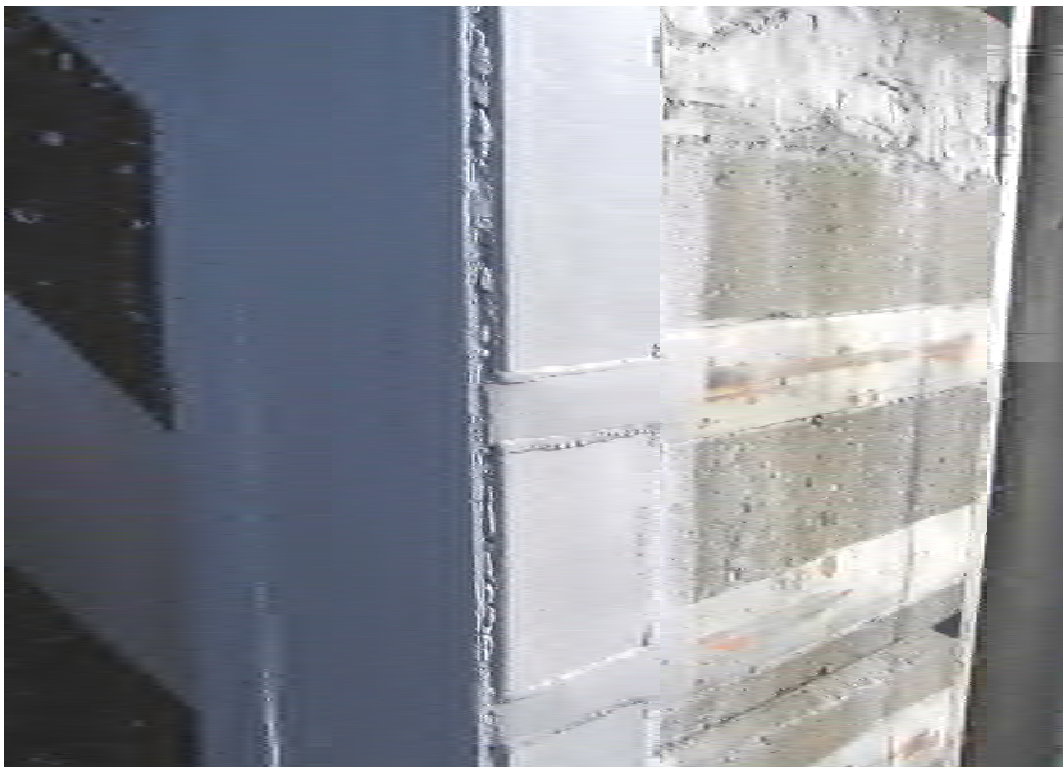
Figure 56. Closeup photo of the 13.5-ft-high by 12-in.-wide top repair steel plate of monolith L-1 on the downstream side of the joint and the 28-in.-high by 12-in.-wide top plate of monolith L-2 on the upstream side of this joint.

The top 13.5 ft of monolith L-1 on the downstream side of the vertical joint undergoing repair did not have wall armor rub strips. Hence, the repair steel plate for this area was not 16-in.-high by 12-in.-wide as were those placed below. This section of repair steel plate required dimensions of 13.5-ft-high by 12-in.-wide. The anchor bolts embedded into the concrete monolith were spaced appropriately for this dimension, as were the holes drilled into the plate. Figures 56 and 57 are photos of the vertical joint showing both sides of the finished repair.

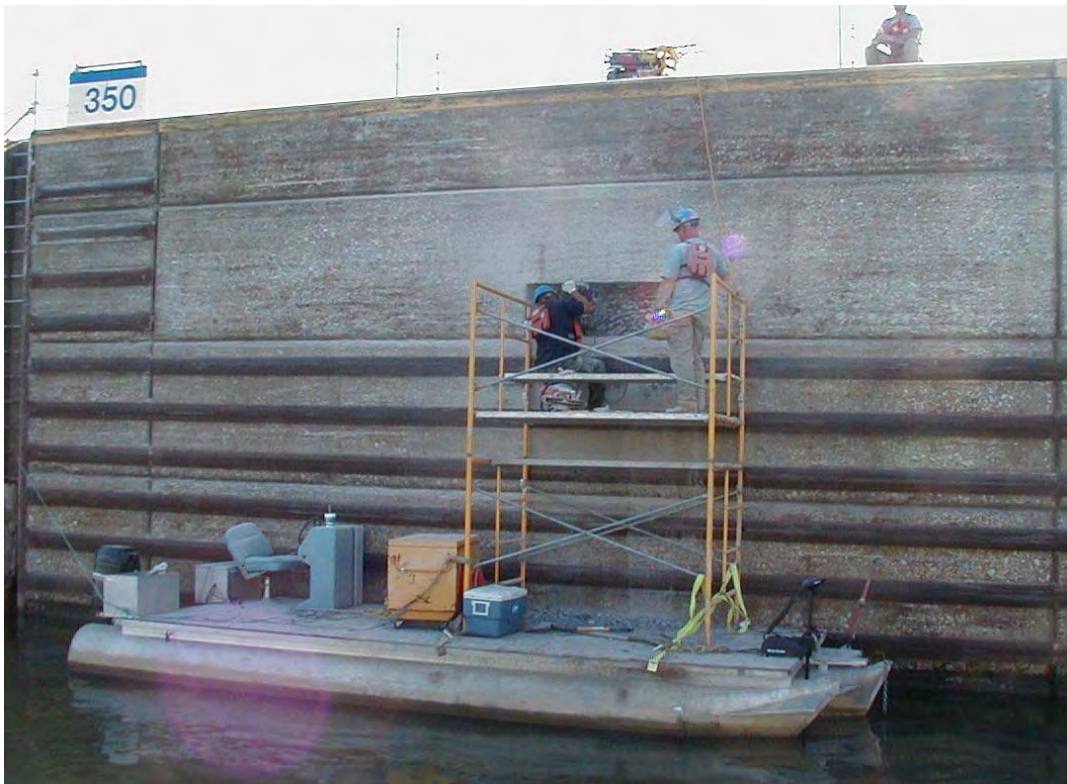
The area of concrete damage selected by CELRL for repair demonstration monitoring was located in lock monolith R-73, upper-river approach wall to the 1,200-ft chamber (Figure 58). The surface area of the damage was about 1.5-ft by 6-ft with an apparent maximum depth of almost 2 ft. Localized concrete honeycomb is the likely cause of this damage. Dropping fresh concrete an excessive distance onto the hardened preceding lift and inadequately consolidating during construction are possible causes for honeycomb. Subsequent cycles of freezing and thawing, combined with barge impact and abrasion, often contribute to removal of the typically weak concrete in such areas. Removal of damaged concrete and replacement with a quality repair material were recommended.

Figure 58. John T. Myers 1,200-ft chamber upper-river approach wall monolith R-73 repair demonstration monitoring.

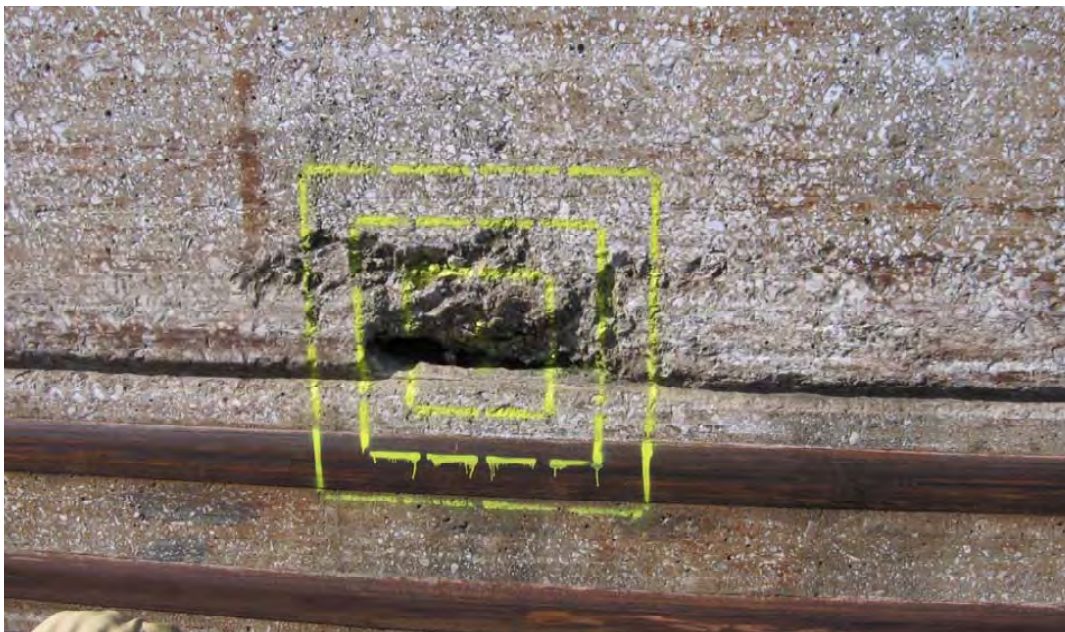
Figure 60. Approximate repair area.

Saw cuts at right angles to the concrete surface shall be made along the perimeter of repairs that involve concrete removal. The surface area of the monolith R-73 repair is approximately 1.5-ft by 6-ft as shown in Figure 60. Depending on the depth of section loss, it may be desirable to extend the repair area to the right by approximately 2 ft. The perimeter of the repair shall be saw cut perpendicular to the chamber face to a minimum depth of 2 in., except for the lower boundary, which is an existing lift joint.

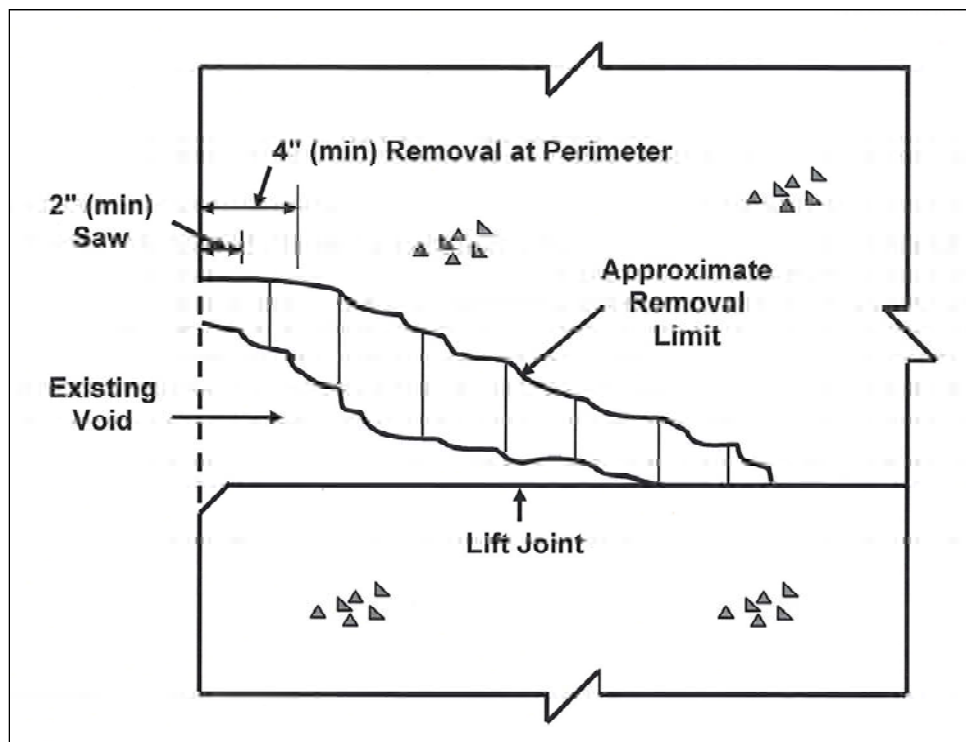
Figure 61. Transverse section through existing void.

Existing concrete within the repair area shall be removed to sound concrete with a 4 in. minimum depth of removal (Figure 61). Continue to remove concrete until aggregate particles are being broken rather than simply removed. Concrete shall be removed to provide a gradual transition from the 4 in. minimum depth to the zone of maximum removal. The upper edge of the concrete surface shall be trimmed to eliminate potential entrapped air pockets that would prevent complete filling of the repair cavity. Proper concrete removal is a primary requirement for the outer two-thirds of the repair cavity. Removing concrete from the back of the confined space is difficult, and removal in this area could be limited to loose material.

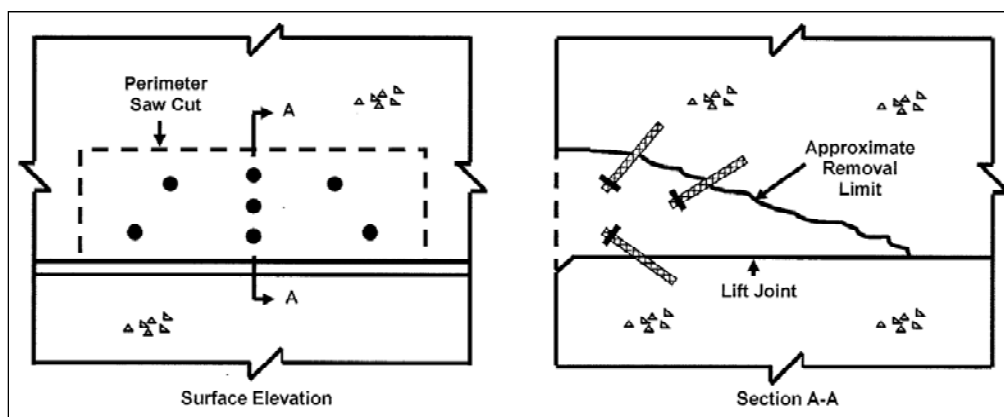
Figure 62. Approximate anchor locations.

Mechanical connections between repair and existing concrete are required. Approximate anchor locations and orientations are shown in Figure 62. The actual number and locations of anchors will be determined in the field depending on size and shape of repair cavity after concrete removal. Anchor sizes and embedment lengths shall be in accordance with supplier's recommendations. Anchors shall have a minimum cover of 2 in. over the headed ends.

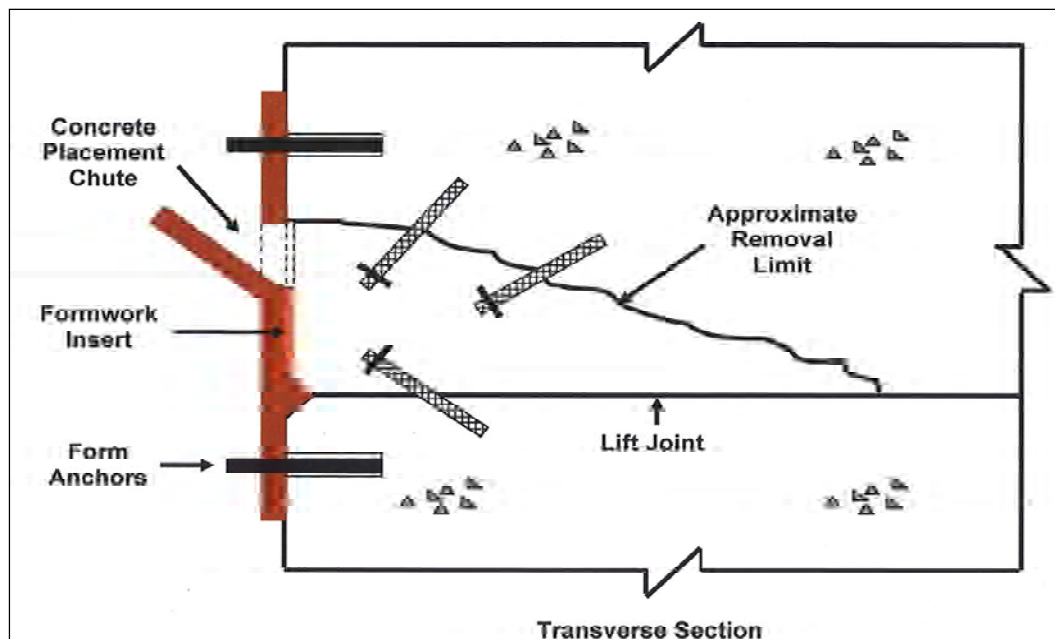
Figure 63. Section through repair cavity showing formwork and placement chute.

Placement openings or chutes are required to place the repair material and allow for insertion of a vibrator for internal consolidation of the repair material (Figure 63). Chutes must be constructed to allow overfilling of the repair cavity prior to consolidation. This is necessary to ensure that the upper edges of the repair cavity are completely filled after consolidation. Forms shall be designed to permit rapid removal without hammering or prying against the repair.

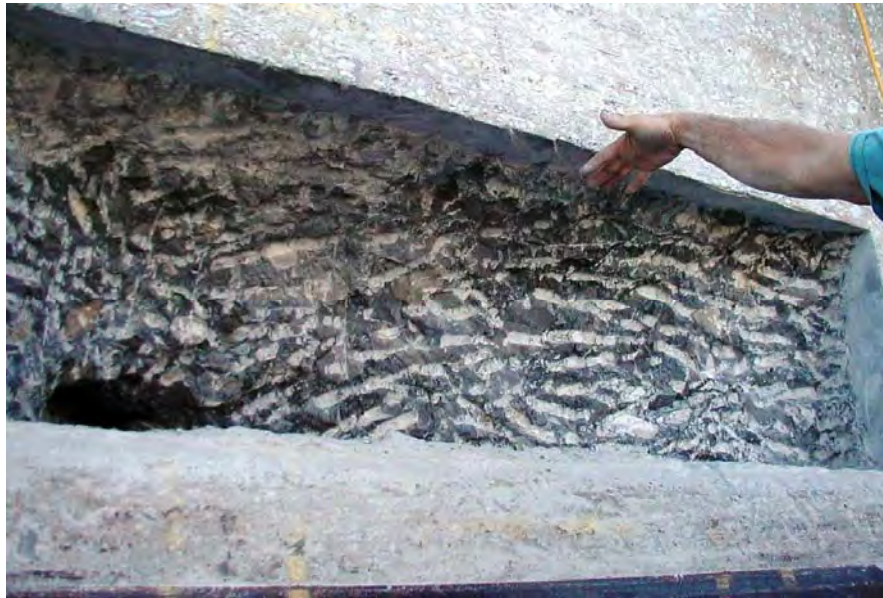
Figure 70. Concrete removed from the 1.75-ft by 6-ft repair.

A hand-held diamond blade saw was used to make a 4-in.-deep cut around the perimeter of the 1.75-ft by 6-ft repair. An electric-powered hand-held impact breaker was used to remove concrete within the repair area (Figure 70). Typically, concrete was removed to a depth of 1 ft to 2 ft, with a small isolated area extending to a depth of about 4 ft.

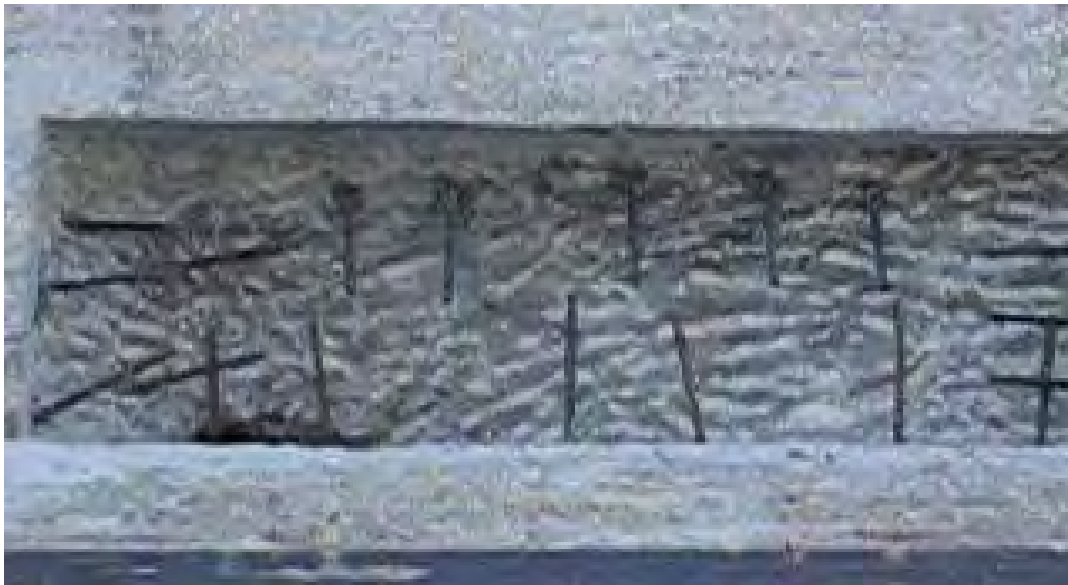
Figure 71. Reinforcing steel rods installed with epoxy in drilled holes as anchors.

No. 5 grade 60 reinforcing steel installed in drilled holes was used as anchors. Lengths of individual anchors varied depending on location and orientation within the repair. Typically, anchors had an embedment depth of 6 in. and minimum cover of 3 in. Anchors were embedded in a medium viscosity epoxy. A total of 18 anchors was installed (Figure 71).

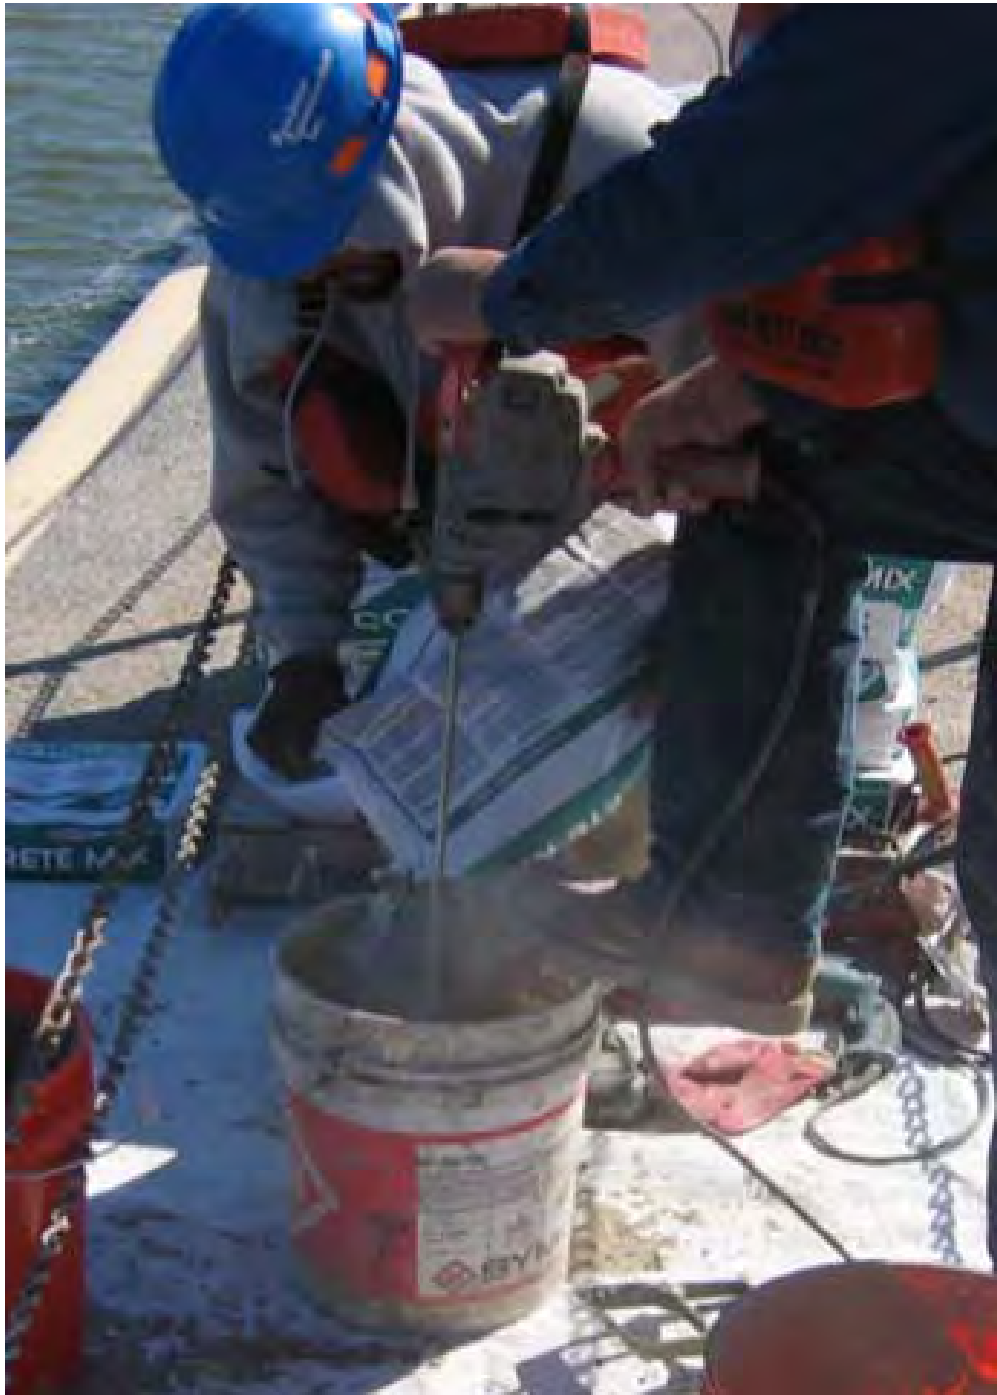
Figure 72. Mixing grout on top of approach wall above repair area.

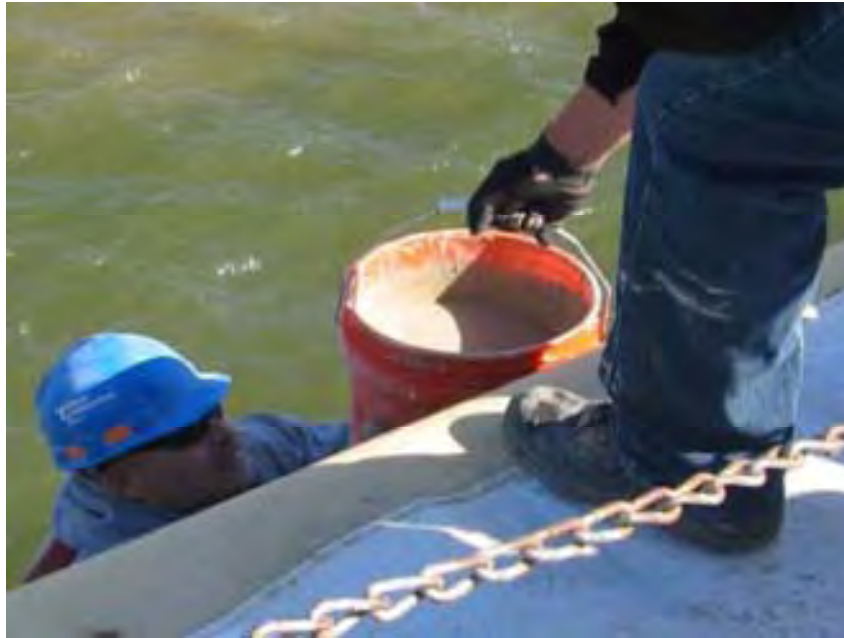
Figure 73. Mixed grout being lowered to the floating platform for placement.

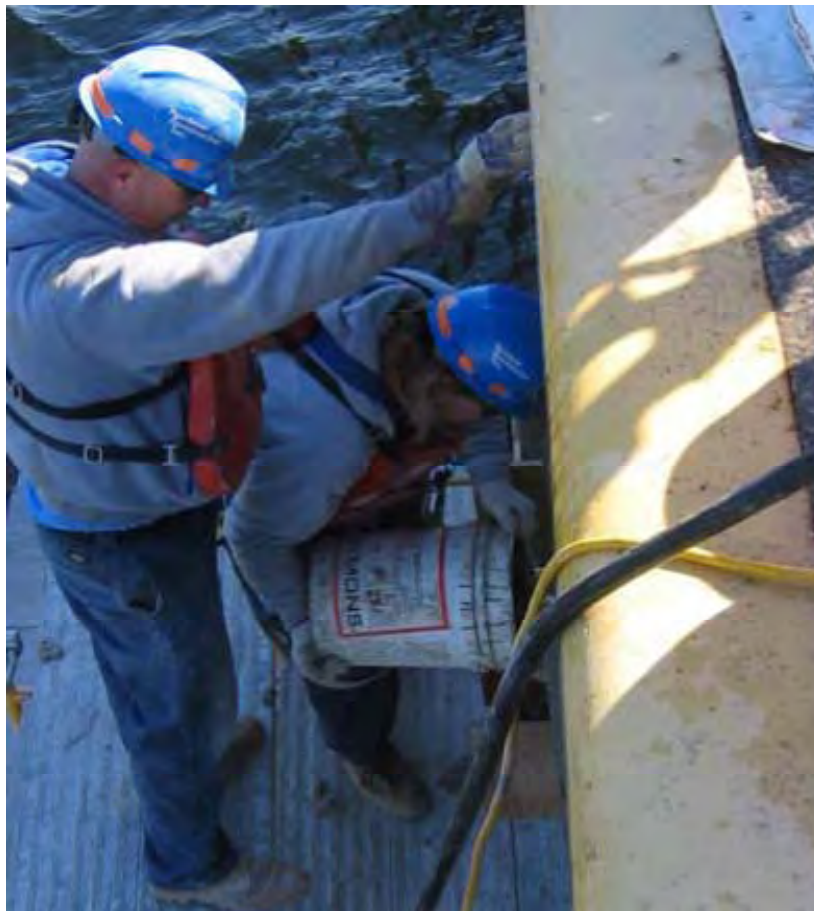
Figure 74. Mixed grout being poured into the formwork.
